## *Hyatt Regency Walkway*

### *Design and Construction*

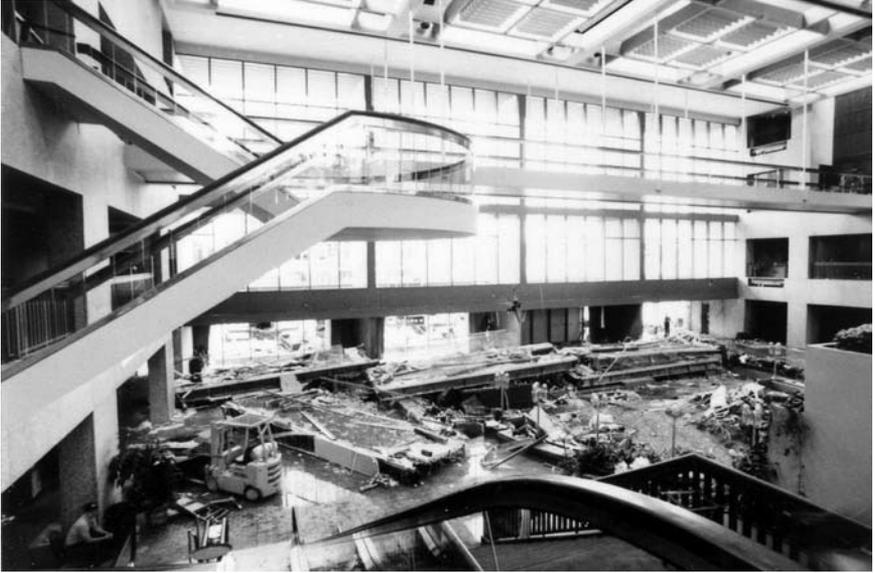
radio station's dance competition (Feld and Carper 1997, pp. 214–215). At 7:05 P.M., a loud crack echoed throughout the building, and the second- and fourth-floor walkways crashed to the ground, killing 114 people and injuring more than 200 others. It was the worst structural failure in the history of the United States (Levy and Salvadori 1992, p. 224). The scene of the collapse is shown in Fig. 2-3.

**Figure 2-3.** Scene of the Kansas City Hyatt Regency collapse.  
Photo provided by Wiss, Janney, Elstner Associates, Inc. (WJE).

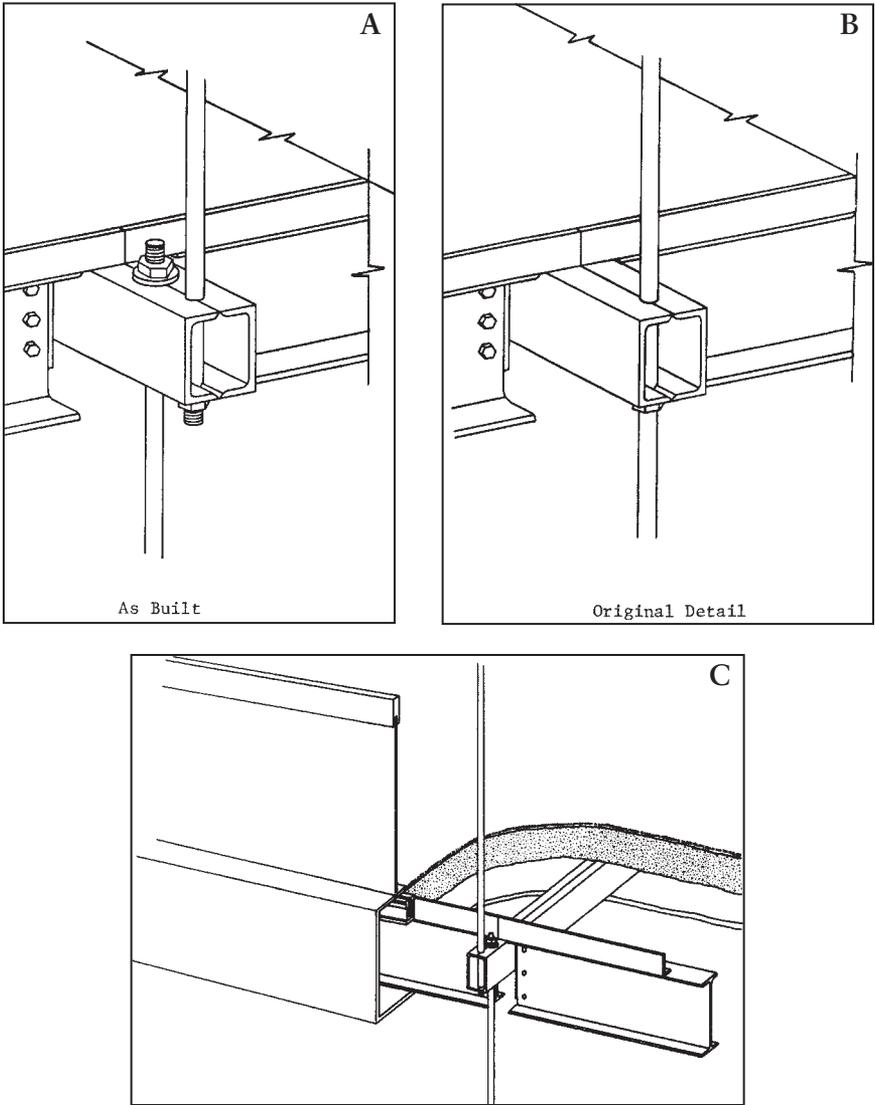
Originally, the second- and fourth-floor walkways were to be suspended from the same rod (Fig. 2-4a) and held in place by nuts. The preliminary design sketches contained a note specifying a strength of 413 MPa

Figure 2-4. Original and as-built hanger details a, b, c.  
Courtesy National Bureau of Standards/National Institute of Standards and Technology.

(60 kip/in.<sup>2</sup>) for the hanger rods, which was omitted on the final structural drawings. Following the general notes in the absence of a specification on the drawing, the contractor used hanger rods with only 248 MPa (36 kip/in.<sup>2</sup>) of strength.

This original design, however, was impractical because it called for a nut 20 ft (6.1 m) up the hanger rod and did not use sleeve nuts. The contractor modified this detail to use two hanger rods instead of one (Fig. 2-4b), and the engineer approved the design change without checking it. This design change doubled the stress exerted on the nut under the fourth-floor beam. Now this nut supported the weight of two walkways instead of just one (Roddis 1993, p. 1548). Figure 2-4c shows how the connection was integrated with the rest of the walkway. It was concealed and could not be easily inspected.

Analysis of these two details revealed that the original design of the rod hanger connection would have supported 90 kN (20,000 lb), only 60% of the 151 kN (34,000 lb) required by the Kansas City building code. Even if the details had not been modified, the rod hanger connection would have violated building standards. As built, however, the connection only supported 30% of the minimum load, which explains why the walkways collapsed at well below maximum load (Feld and Carper 1997, pp. 218–222). The NBS built and tested a full-scale mock-up to simulate the failure and found that the static effects were much more significant than the dynamic effects (Kaminetzky 1991, p. 219).

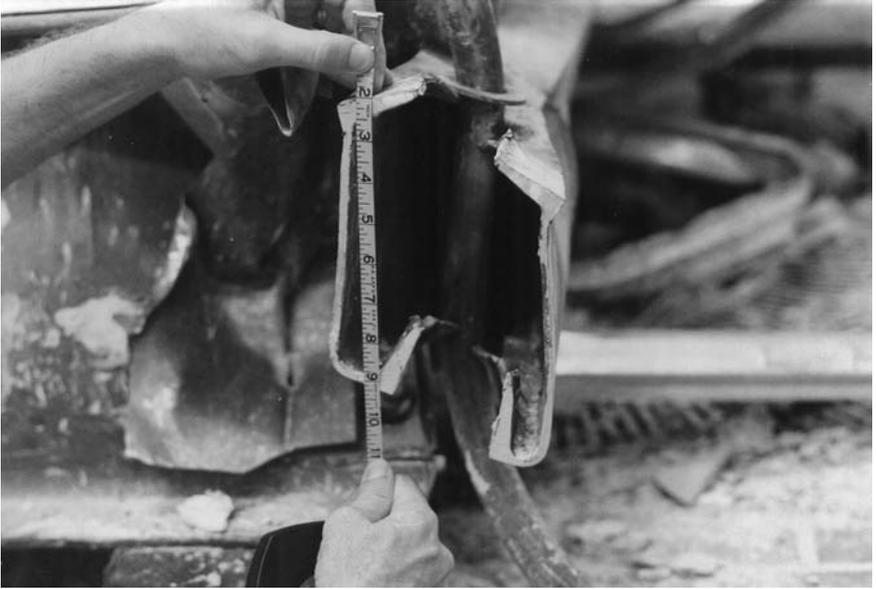
Moncarz and Taylor (2000) discussed the structural system in detail and analyzed the demand-to-capacity ratios of the components. Their firm, Failure Analysis Associates, had been retained by the project architect. Each walkway was made of lightweight concrete on metal decking, supported by longitudinal I-beam W 16 × 26 stringers. The designation “W 16 × 26” means an I-shaped wide flange section, 16 in. (406 mm) deep and weighing 26 lb per linear foot (mass 38.7 kg per linear meter). The transverse beams were each made of two MC 8 × 8.5 channels, welded toe to toe to form a box. A channel shape designated as MC 8 × 8.5 is 8 in. (203 mm) deep and weighs 8.5 lb per linear foot (mass 12.7 kg per linear meter). Holes were drilled through the welds to hold the support rods. The bearing area for the hanger rod washer was flattened by grinding, further reducing capacity (Moncarz and Taylor 2000, p. 47). The failed fourth-floor beam is shown in Fig. 2-5, and the hanger rod is shown in Fig. 2-6.

**Figure 2-5.** Failed fourth-floor beam.  
Courtesy Lee Lowery, Texas A&M University.

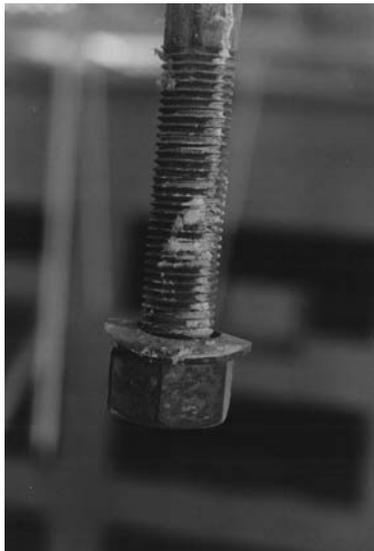
**Figure 2-6.** Hanger rod.  
Courtesy Lee Lowery, Texas A&M University.

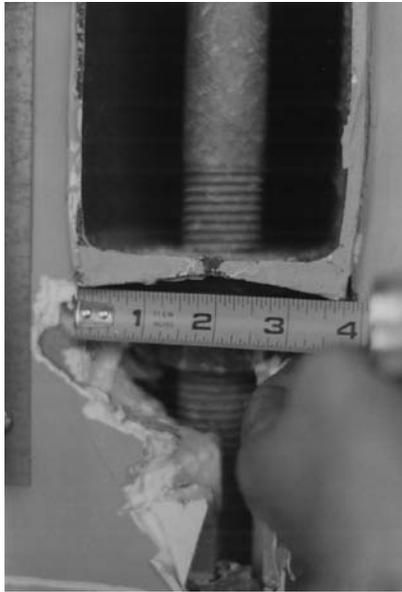
Failure Analysis Associates carried out sophisticated computer modeling (finite element) analysis of the box beam connection. The connection was near failure with dead load only, and an additional live load of 7 people on the upper bridge and 56 on the lower bridge proved to be enough to trigger failure. Plastic deformation of the box beam was estimated at 3–6 mm (0.12–0.24 in.), which was hidden by the finish and fireproofing materials (Moncarz and Taylor 2000, p. 49). The third-floor beam, which did not fail, is shown in Fig. 2-7. This box beam showed substantial permanent deformation.

**Figure 2-7.** Third-floor beam showing deformation.  
 Courtesy Lee Lowery, Texas A&M University.

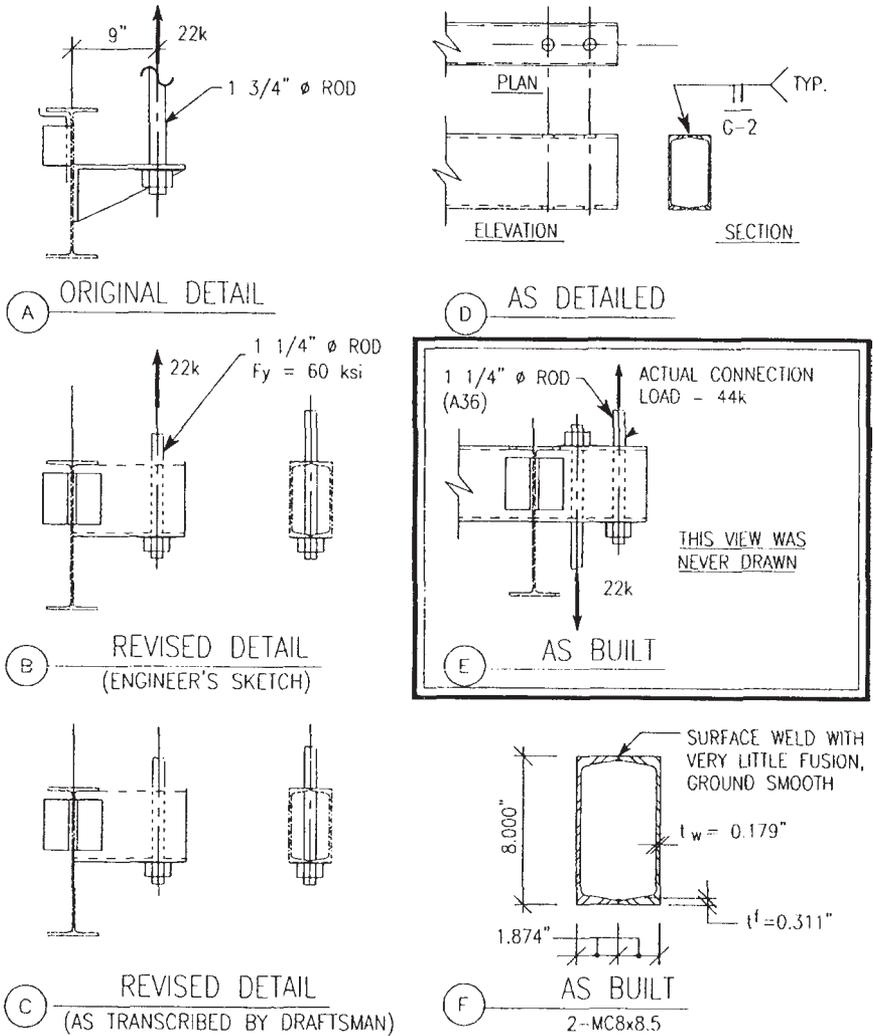
Luth (2000) details the steps in the design and construction process. He makes the important point that the critical connection was never designed and that the view represented by Fig. 2-4 was never drawn until after the failure. Luth's illustration of the various stages in the history of the connection is shown in Fig. 2-8.

Figure 2-8. The evolution of the failed connection.  
Source: Luth (2000).

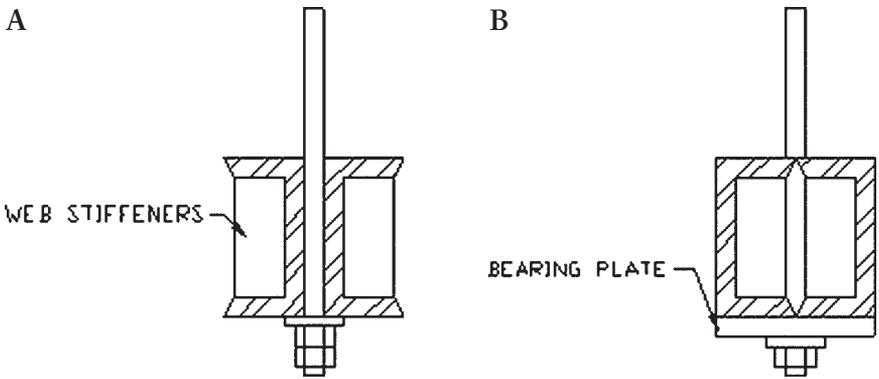
Figure 2-9a, b. Proposed alternative connection designs.

Many articles written referred to the connection as a “designed connection,” and many alternate, satisfactory designs were presented. Two are shown in Fig. 2-9, based on Kaminetzky (1991, pp. 220–221).

The NBS report recommended that concentrated loads never be applied to flanges of steel sections. Load-distributing plates (shown in Fig. 2-9) should be used (Feld and Carper 1997, pp. 222–223).
