## *L'Ambiance Plaza Collapse*

The death of 28 workers in the April 23, 1987, construction collapse of the L'Ambiance Plaza building in Bridgeport, Connecticut, triggered a massive rescue effort and several investigations. Unfortunately, to this day the true cause of the collapse remains in dispute because a settlement ended all investigations. This was a lift-slab project.

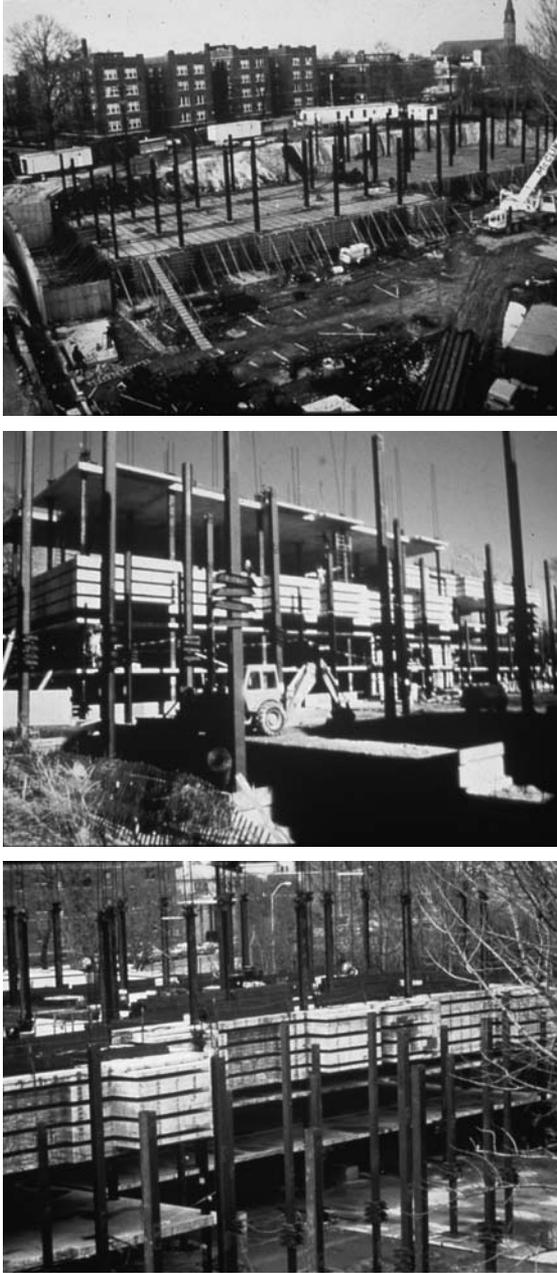
Using the lift-slab method, the floor slabs for all 16 levels were constructed on the ground, one on top of the other, with bond breakers between them (Fig. 4-9a). Then packages of two or three slabs were lifted into temporary position by a hydraulic lifting apparatus and held in place by steel wedges. The lifting apparatus consisted of a hydraulic jack on top of each column, with a pair of lifting rods extending down to lifting collars cast in the slab (Figs. 4-9b and 4-9c).

Figure 4-9. L'Ambiance Plaza Lift Slab Construction.  
Courtesy National Institute of Standards and Technology.

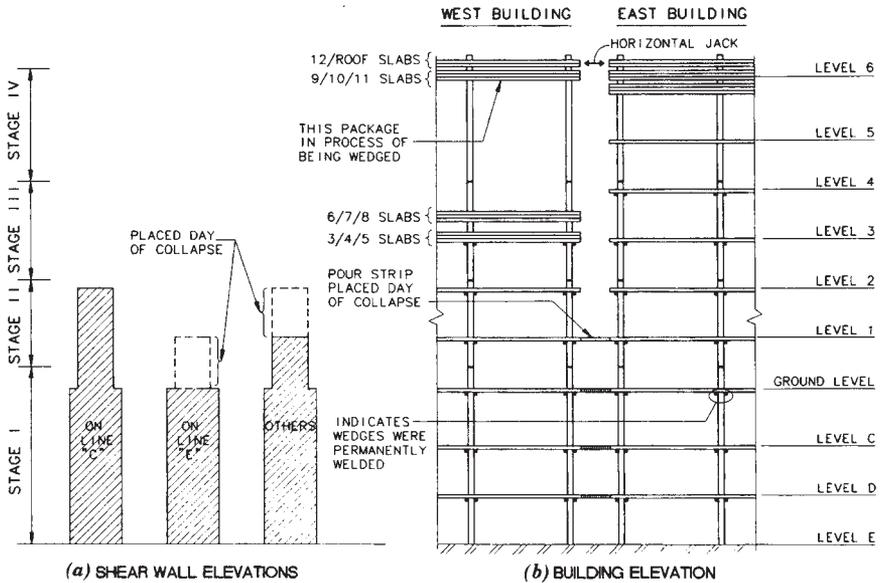
At the time of the collapse, the building was a little more than halfway completed. In the west tower, the 9th, 10th, and 11th floor slab package was parked in stage IV directly under the 12th floor and roof package (Fig. 4-11). The shear walls were about five levels below the lifted slabs (Cuoco et al. 1992).

Figure 4-11. Elevation of L'Ambiance Plaza just before collapse.

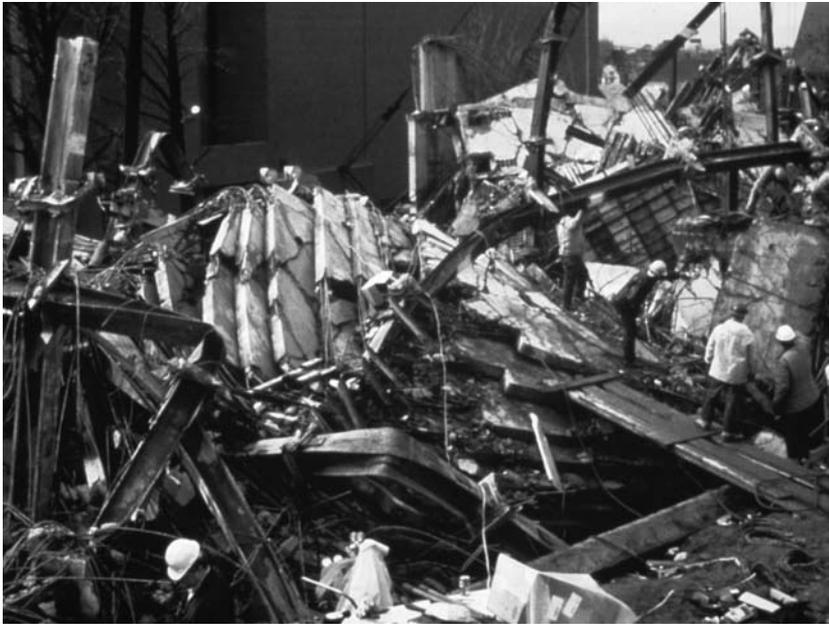
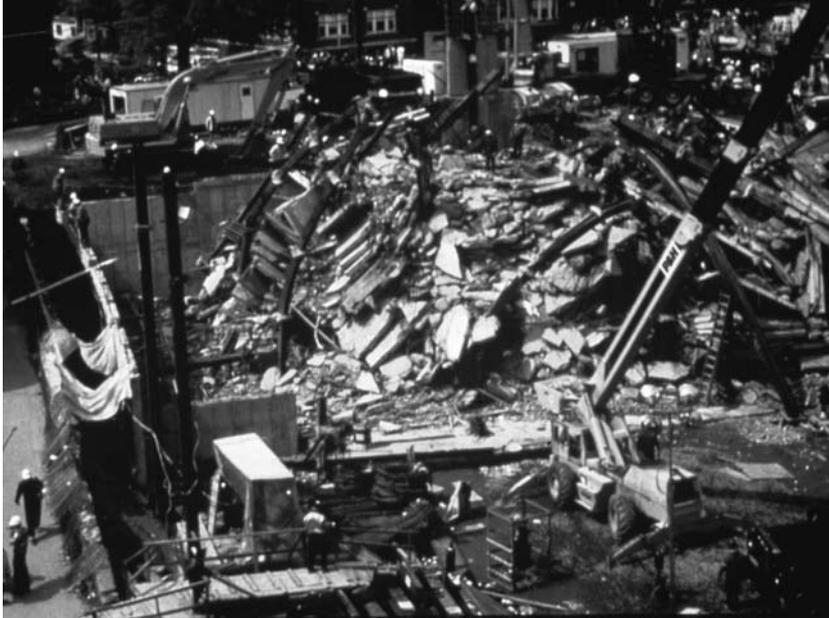
The workers were tack-welding wedges under the 9th-to-11th floor package to temporarily hold them in position, when a loud metallic sound followed by rumbling was heard. Kenneth Shepard, an ironworker who was installing wedges at the time, looked up to see the slab over him “cracking like ice breaking.” Suddenly, the slab fell onto the slab below it, which was unable to support this added weight and fell in turn. The entire structure collapsed, first the west tower and then the east tower, in 5 s, only 2.5 s longer than it would have taken an object to free fall from that height. Ten days of frantic rescue operations revealed that 28 construction workers had died in the collapse, making it the worst lift-slab construction accident ever. Kenneth Shepard was the only one on his crew to survive (Levy and Salvadori 1992). The collapsed structure is shown in Fig. 4-12.

Figure 4-12a, b. The collapsed structure of L'Ambiance Plaza.  
Courtesy National Institute of Standards and Technology.

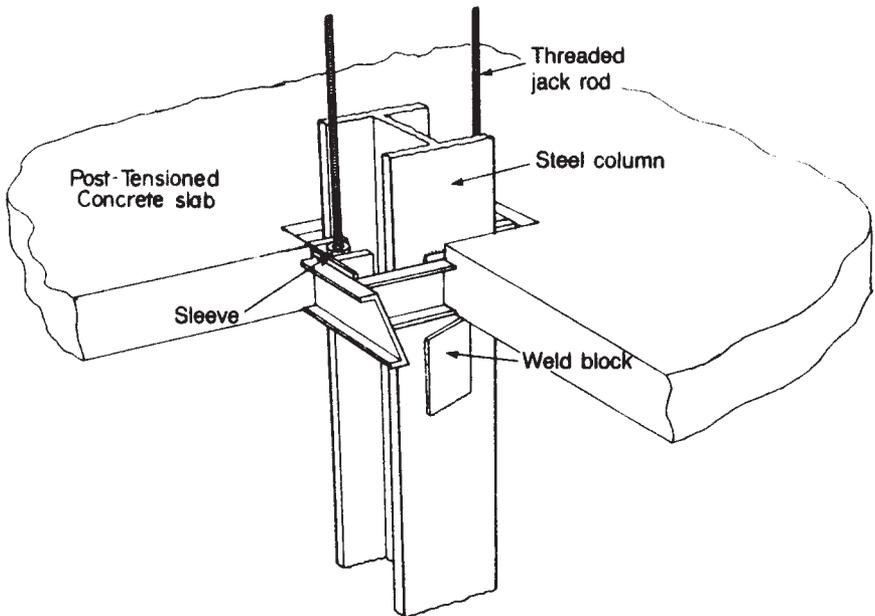
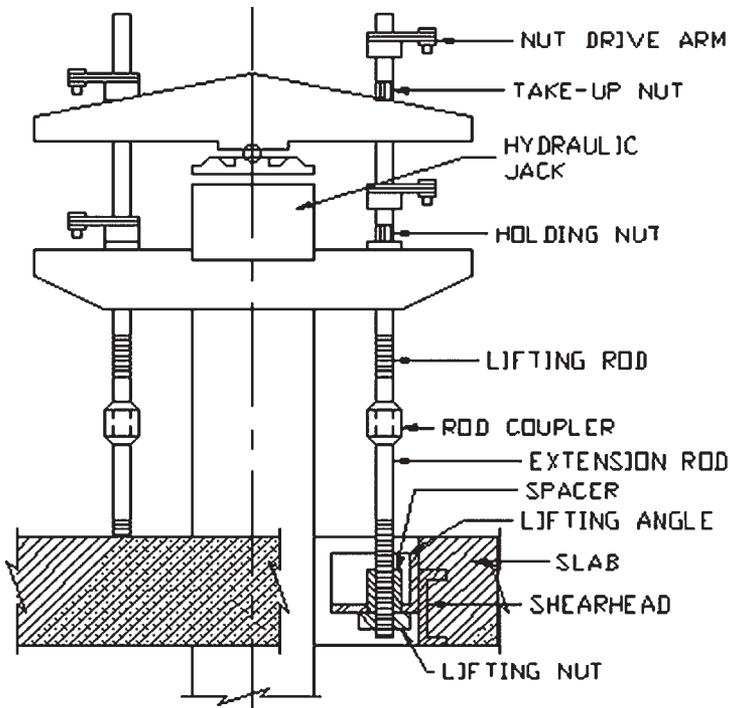
The NBS investigation concluded that the failure occurred at the building's most heavily loaded column, E4.8, or the adjacent column, E3.8, as a result of a lifting assembly failure (Fig. 4-13). The shear head reinforced the concrete slab at each column, transferred vertical loads from the slabs to the columns, and provided a place of attachment for the lifting assembly. It consisted of steel channels cast in the concrete slab, leaving a space for the lifting angle. The lifting angle had holes to pass the lifting rods through. These rods were raised by the hydraulic jacks on the columns above them (Levy and Salvadori 1992).

**Figure 4-13a.** Lifting assembly.  
*Source:* Poston et al. (1991).

Figure 4-13b. Lifting assembly.  
 Source: Martin and Delatte (2000).

Shortly before the collapse, the workers lifted the 9th-to-11th floor package to its final position and began tack-welding the steel wedges into place. They used a jack on top of the column E4.8 or E3.8 to slightly adjust the position of the slab, overloading the lifting angles. When the shear heads and lifting angles had lifted the package of three 3.13 MN (320-ton) slabs, they were dangerously close to their maximum capacity, so adding even the smallest of loads could exceed that maximum.

The lifting capacities of the two types of jacks used were too small for the 9.38 MN (960-ton) package. The regular jacks have a maximum load of 869 kN (89 tons), whereas the super jacks have a maximum load of 1.47 MN (150 tons). NBS also tested the shear head and lifting angle and found that the angles tended to twist as the loads approached 781 kN (80 tons), because although the angles had enough strength, they did not have enough stiffness. The force deformed the lifting angle, allowing the jack rod and lifting nut to slip out of the lifting angle and hit the column with 333 kN

(75,000 lb) of force. This load accounted for the loud noise that Kenneth Shepard heard and the indentation found in that column. After this initial slip, the jack rods and lifting nuts in the entire E line progressively slipped, causing the 9th floor slab to collapse, initiating the collapse of the entire building (Korman 1987).

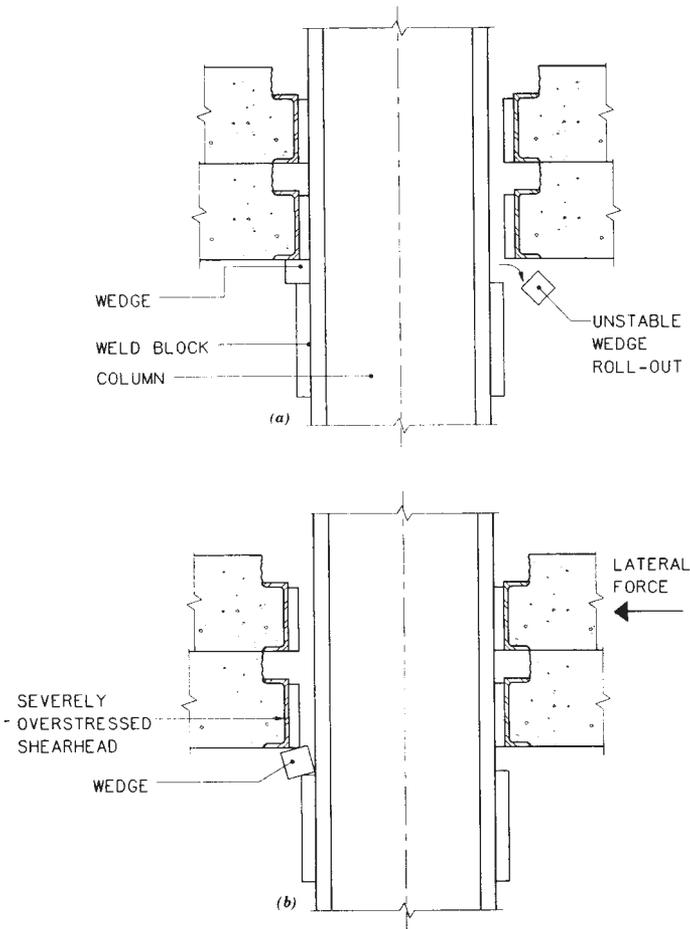
Their investigation also found that the shear head gaps on columns 3E and 3.8E (16 mm, 0.628 in.) were much larger than the gaps on the rest of the building (5.92–8.31 mm, 0.233–0.327 in.) and other buildings built with the lift-slab technique (6.35–9.53 mm, 0.250–0.375 in.). In addition to these abnormally large gaps, the shear heads used on these two columns did not have cutouts in their lifting angles to restrict shifting, and they were installed eccentrically. Finally, until a wedge was completely welded into place, it depended on friction to hold it. Normally, friction is sufficient. The large shear head gaps on columns 3E and 3.8E and the presence of hydraulic fluid on these wedges, however, would have demanded an extremely high friction coefficient to hold the wedges in place.

On the day of collapse, the lateral load from the hydraulic jack was exerted on the heavily loaded wedges, causing the west wedge to roll. Then the local adjustments to slab elevations caused the remaining wedge to roll out, initiating the collapse of the 12th floor–roof package and the west tower (Fig. 4-14). Forces transmitted through the pour strips or the horizontal jack, or the impact of the debris from the west tower, triggered the east tower's collapse (Cuoco et al. 1992). Zallen and Peraza (2004, pp. 28–29) refer to this as “theory 3—wedges falling out.”

**Figure 4-14.** Wedges and wedge roll-out mechanism.

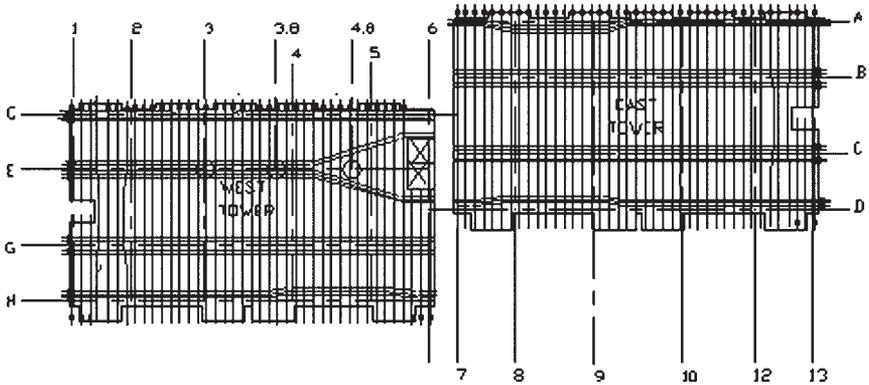
SSE analyzed the structural behavior of a typical west tower floor slab with respect to the unusual layout of the post-tensioning tendons (Fig. 4-15). The tendons in the east tower followed a typical two-way banded post-tensioning tendon layout. In this layout, the vertical tendons distributed the weight of the slab to the east-west column lines, which in turn distributed

Figure 4-15. Post-tensioning tendon layout.

the weight to the columns. The west tower, however, deviated from this pattern. At column 4.8E, the tendons split in two, both diverging from the column line. In the west tower, the vertical tendons still distributed the slab's weight to the column line. Along line E, however, there are no tendons to carry this weight. This setup violated the American Concrete Institute Building Code (ACI 1983). Kaminetsky points out that the code stipulates “a minimum of two tendons shall be provided in each direction through the critical shear section over columns” (1991, p. 84).

Furthermore, the design details of the post-tensioned floor slabs do not show the location of the shear walls or the openings for the walls at columns 11A, 8A, and 2H. The design did not take these openings into account. Detailed finite-element analysis showed that tensile stresses along column line E, east of column 4.8E, exceeded the cracking strength of the concrete. Therefore, once a crack began, it would immediately spread to column 4.8E. In addition, under ideal lifting conditions, the analysis demonstrated that column 2H would have high compressive and punching shear stresses (Poston et al. 1991). Zallen and Peraza (2004, p. 29) refer to this as “theory 5—improper post-tensioning design.”
