## *Hyatt Regency Walkway*

### *Design and Construction*

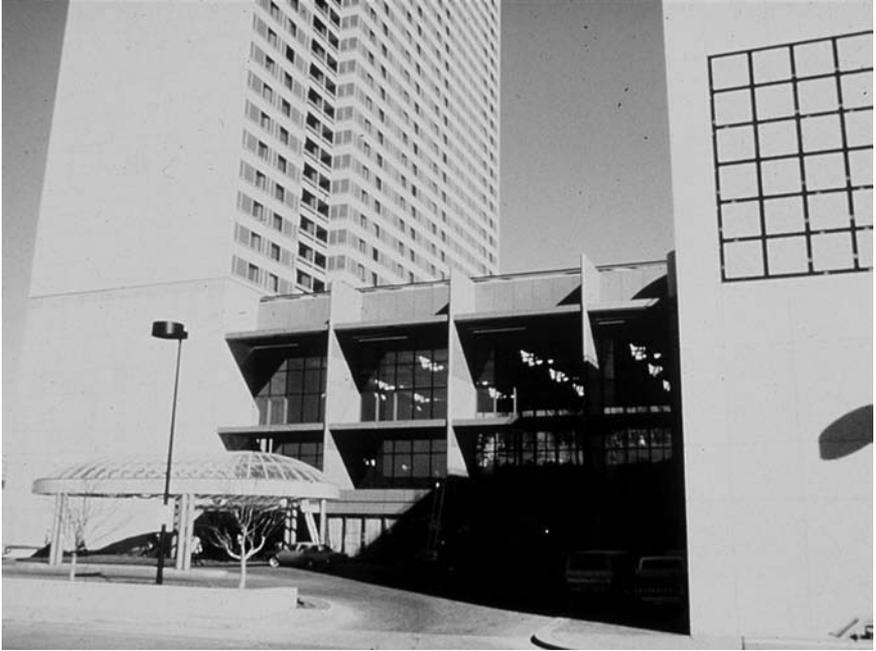
**Figure 2-1.** The Kansas City Hyatt Regency exterior.  
 Courtesy National Bureau of Standards/National Institute of Standards and Technology.

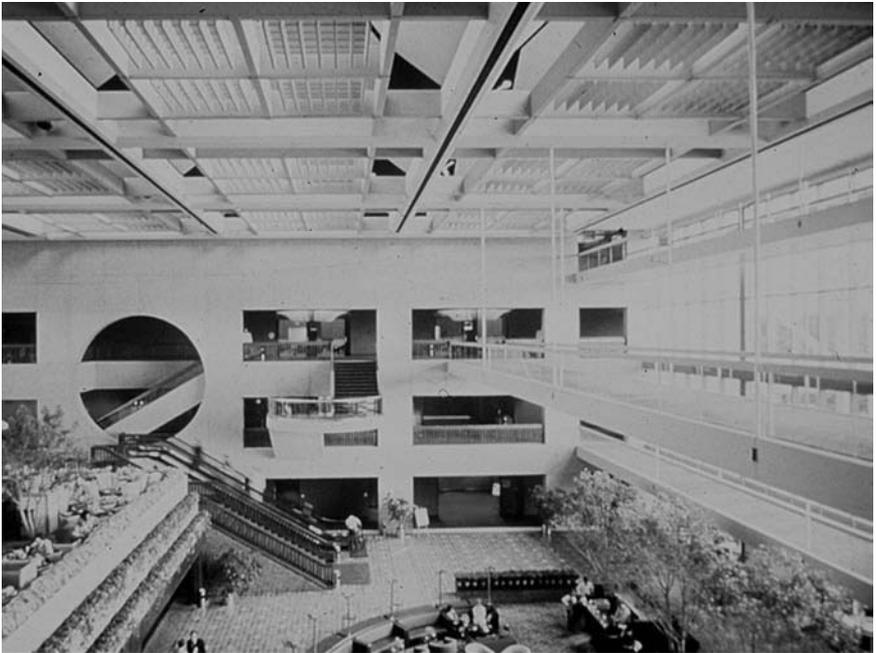
ceiling (Feld and Carper 1997, p. 216). The walkways before the collapse are shown in Fig. 2-2.

**Figure 2-2.** The Kansas City Hyatt Regency atrium walkways.  
 Courtesy National Bureau of Standards/National Institute of Standards and Technology.
